# VOLVO OCEAN RACE INDEPENDENT REPORT INTO THE STRANDING OF VESTAS WIND

*The Vestas Wind Report (Version 1.2)*

An Independent Report that was convened by the Volvo Ocean Race following the stranding of the yacht Vestas Wind on 29 November 2014 on the Cargados Carajos Shoals 240 nm north east of Mauritius while competing in the 2014 – 2015 Volvo Ocean Race round the world.

31 January 2015

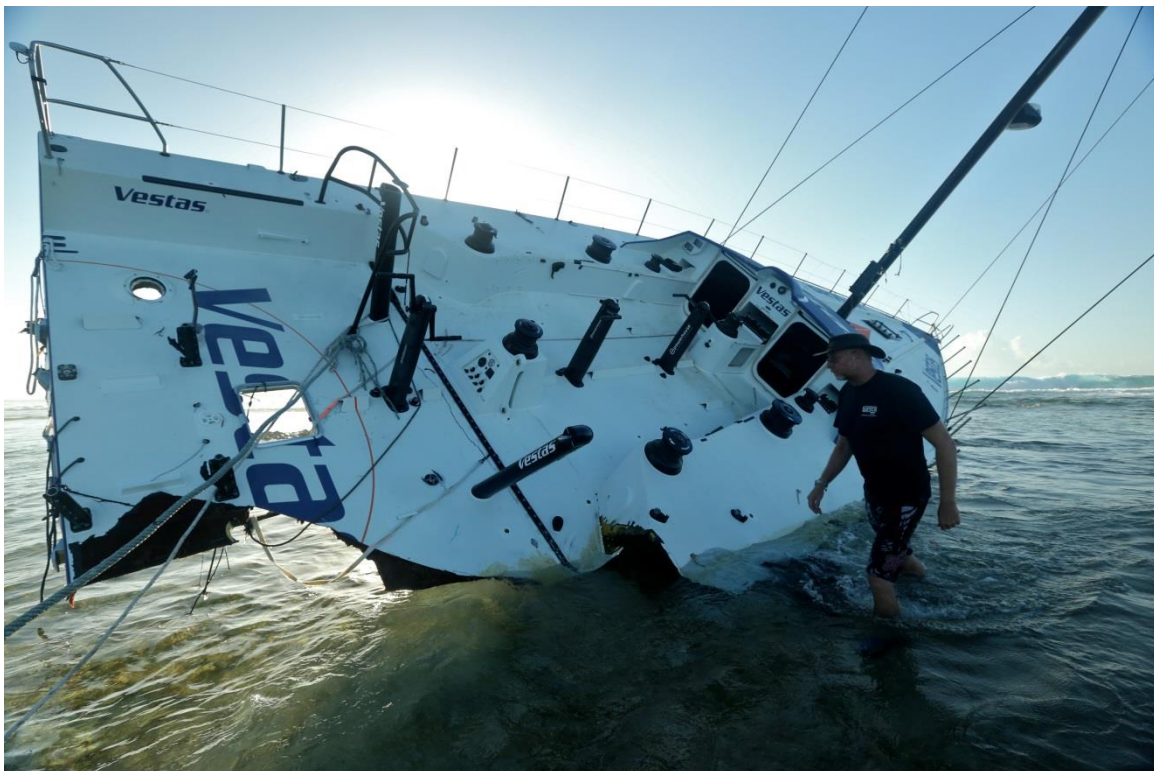
94. The stern of the boat was being destroyed (Figure 6) and there was concern that the second liferaft could be lost if it was not released. A lot of gear from the aft watertight compartment, including the anchors and emergency water supplies had already been lost when the compartment was opened to the sea. The spare first aid stores had also been lost from the emergency locker which is forward of the aft watertight compartment, when the bottom of the boat was damaged in that area.

Figure 6 – A telling shot of the damage sustained to the starboard quarter  
Credit: Shane Smart/ Volvo Ocean Race
