Aviation Investigation Preliminary Report

Location:	Portland, OR	Accident Number:	DCA24MA063
Date & Time:	January 5, 2024, 17:14 Local	Registration:	N704AL
Aircraft:	Boeing 737-9	Injuries:	177 None
Flight Conducted Under:	Part 121: Air carrier - Scheduled

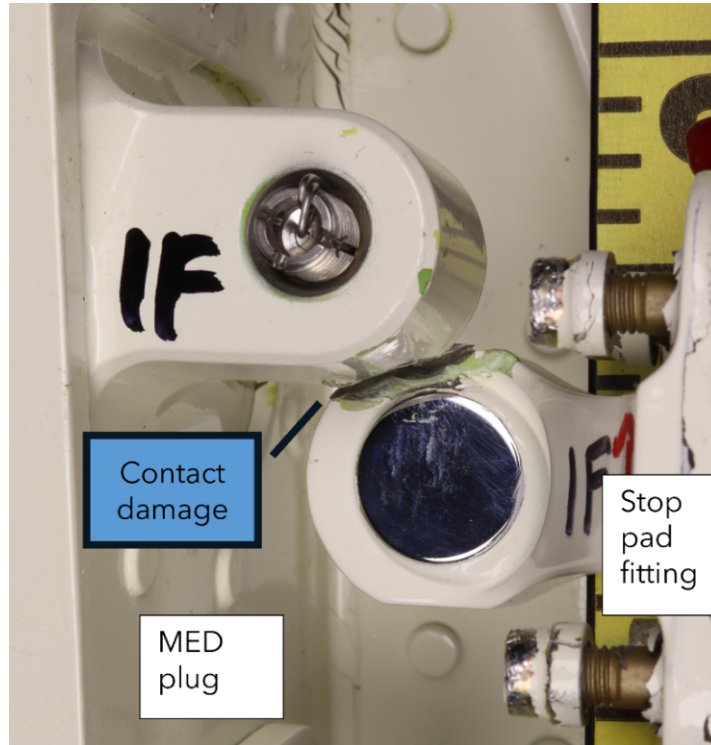
Contact damage was noted on the lower sides of the 12 stop pins and fittings on the MED plug. Corresponding contact damage was noted on the 12 stop pads and fittings attached to the fuselage. Overall, the damage was consistent with the MED plug translating upward, outboard, and aft during the separation. Figure 9 shows damage features at the upper forward stop location and is representative of the other stop locations.

Figure 9. Witness mark matching between upper forward MED plug stop pin fitting and stop pad fitting as received in the NTSB Materials Laboratory.
