# VOLVO OCEAN RACE INDEPENDENT REPORT INTO THE STRANDING OF VESTAS WIND

*The Vestas Wind Report (Version 1.2)*

An Independent Report that was convened by the Volvo Ocean Race following the stranding of the yacht Vestas Wind on 29 November 2014 on the Cargados Carajos Shoals 240 nm north east of Mauritius while competing in the 2014 – 2015 Volvo Ocean Race round the world.

31 January 2015

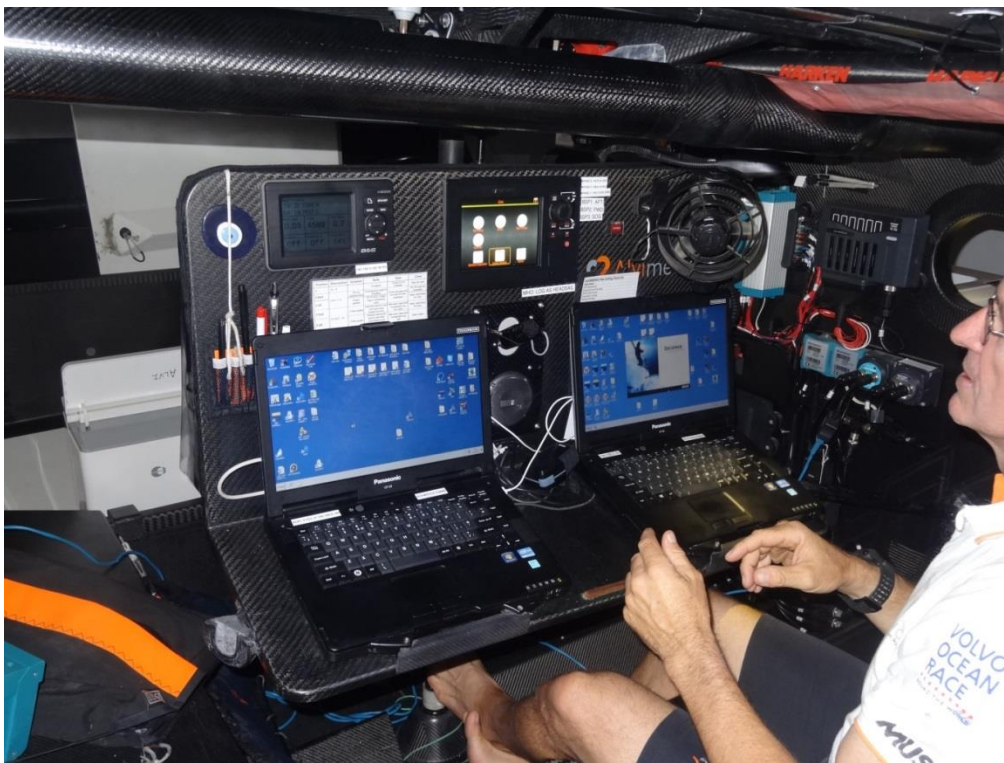
Figure 3 – Nav Station on board Alvimedica. A MFD display is located above and centred between the laptop screens. Nav station rotates on a vertical axis when boats are on the other tack.

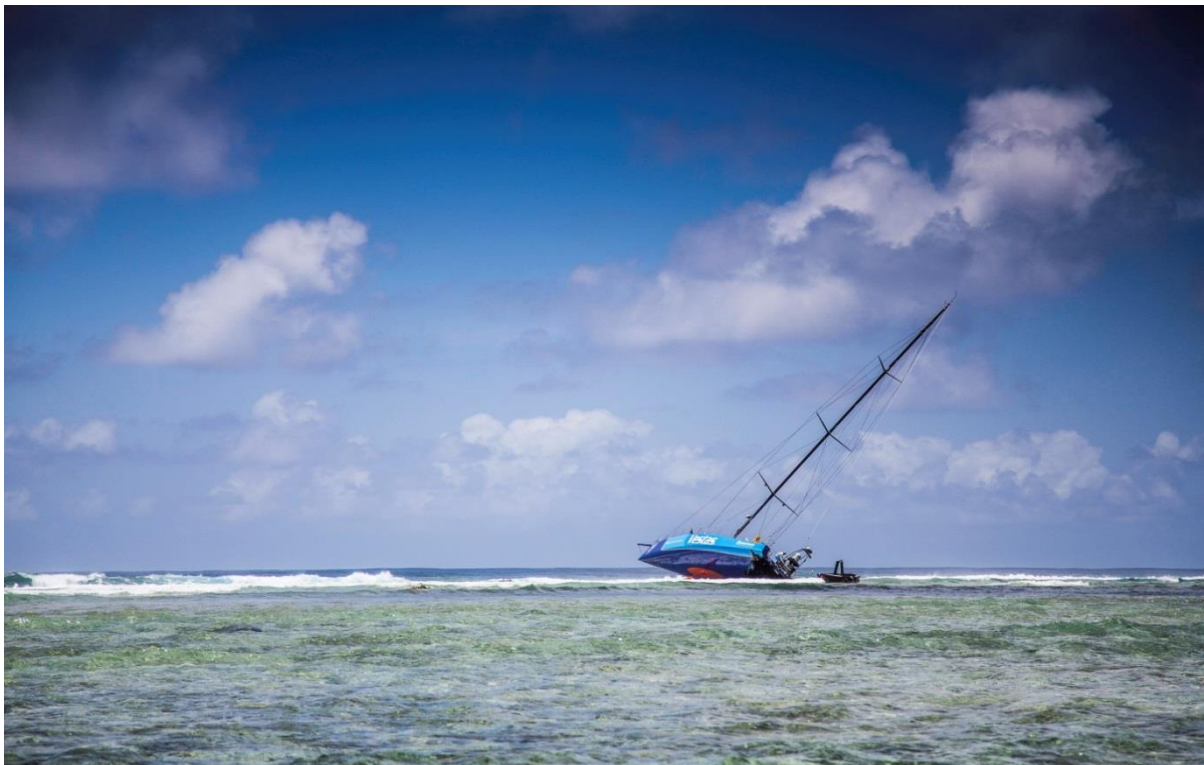
Figure 7 – *Vestas Wind* the day following the grounding with the crew starting the retrieval operation  
Credit: Brian Carlin/Team Vestas Wind/Volvo Ocean Race

103. *Vestas Wind* was itself lifted over the reef's edge and onto the reef shortly after the crew left the boat – possibly about 0400 – and came to rest in the well photographed position at Figure 7. The next day the crew were amazed by where the boat had moved to from where it was abandoned.

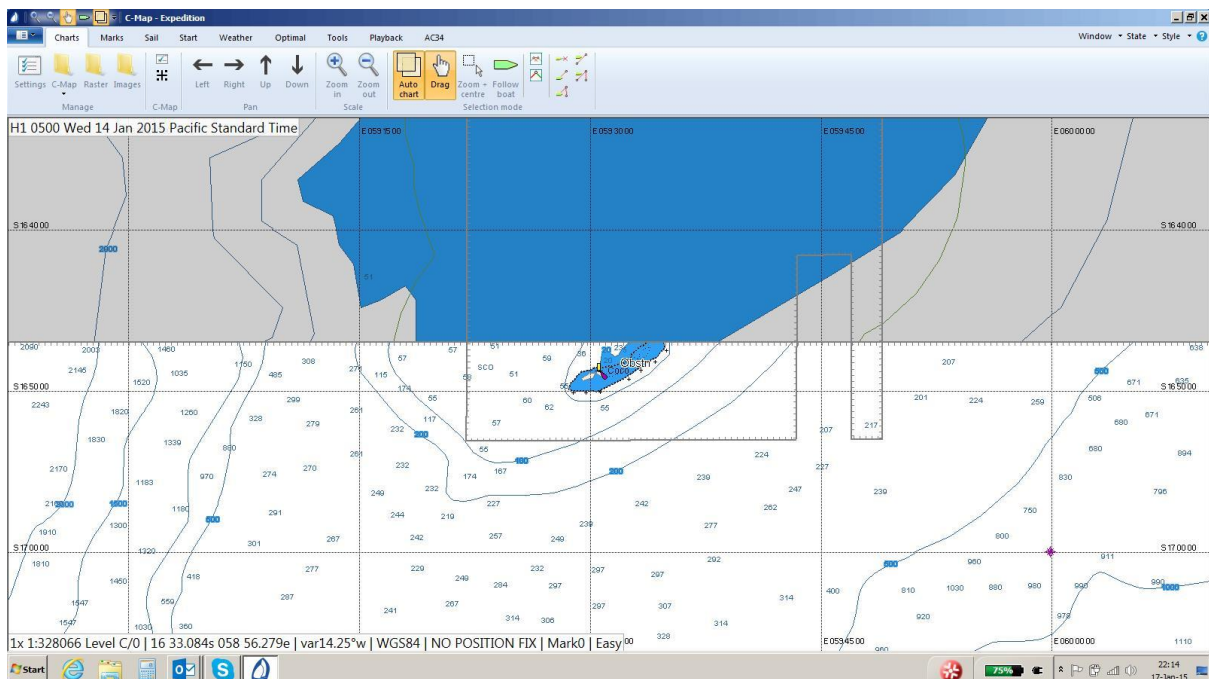
Figure 14 – Southern tip of Cargados Carajos Shoals – showing the chart by chart display on C-Map/Expedition at Level C/0 Scale1: 328,066 and displaying a small segment of the larger scale chart

was shown at Level C on C-Map (Figure 14), but it was removed by a small correction<sup>14</sup> to the larger scale charts of the area in 2012.

- chart bounds outlining the Cargados Carajos Shoals reef,
- the name Cargados Carajos Shoals is shown providing an alert to shallow water,
- the economic boundaries are shown, although when using the default colour pallet, they are difficult to see against the blue 200m depth area and can also be confused with depth contour lines, and
- at one location to the south of the shoals, a small piece of a larger scale chart can be seen at Zoom Level C (Figure 14).

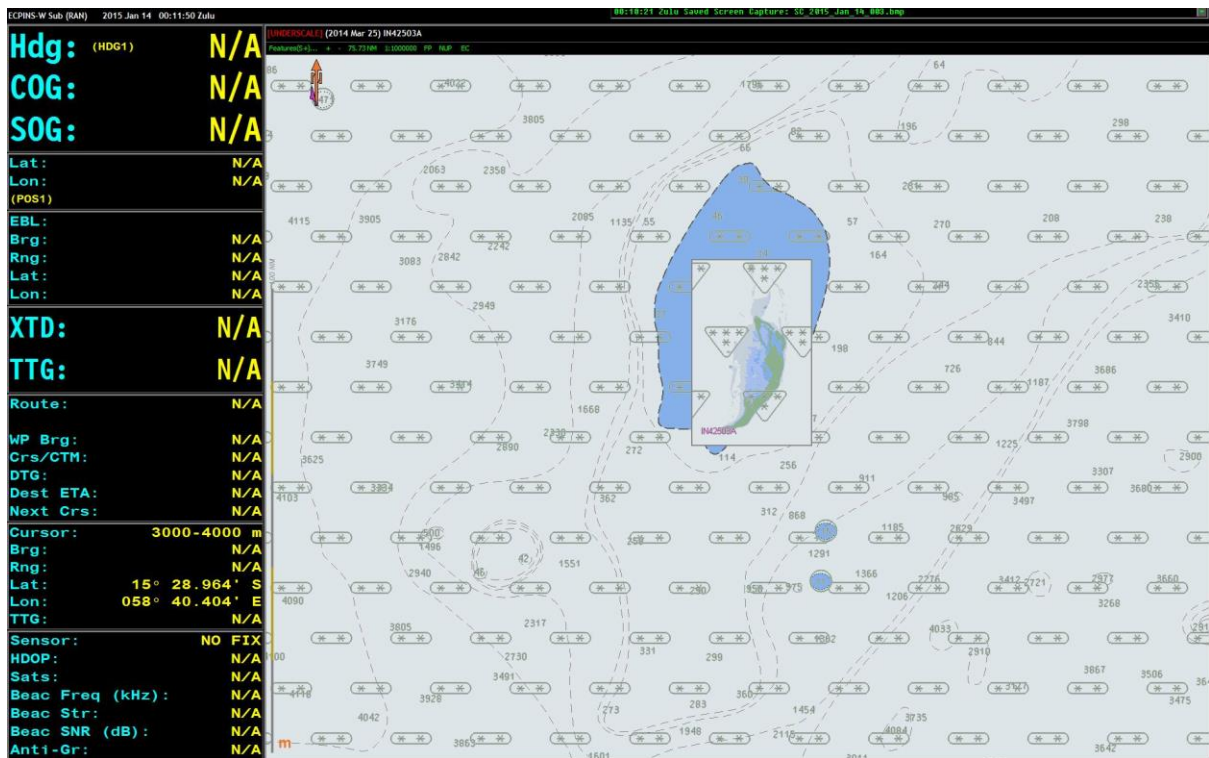
Figure 17 – The ENC data quality feature. An ECDIS screen shot of French ENC FR274880 Zoomed in on Cargados Carajos Shoals – with ZOC switched on displaying 4 stars ZOC B at the reef and 2 stars ZOC D in surrounding ocean
